Supplemental Information

Corrosion in a STP Sump: What Causes It and What Can Be Done About It?

Part 2. Sumps that were scored.

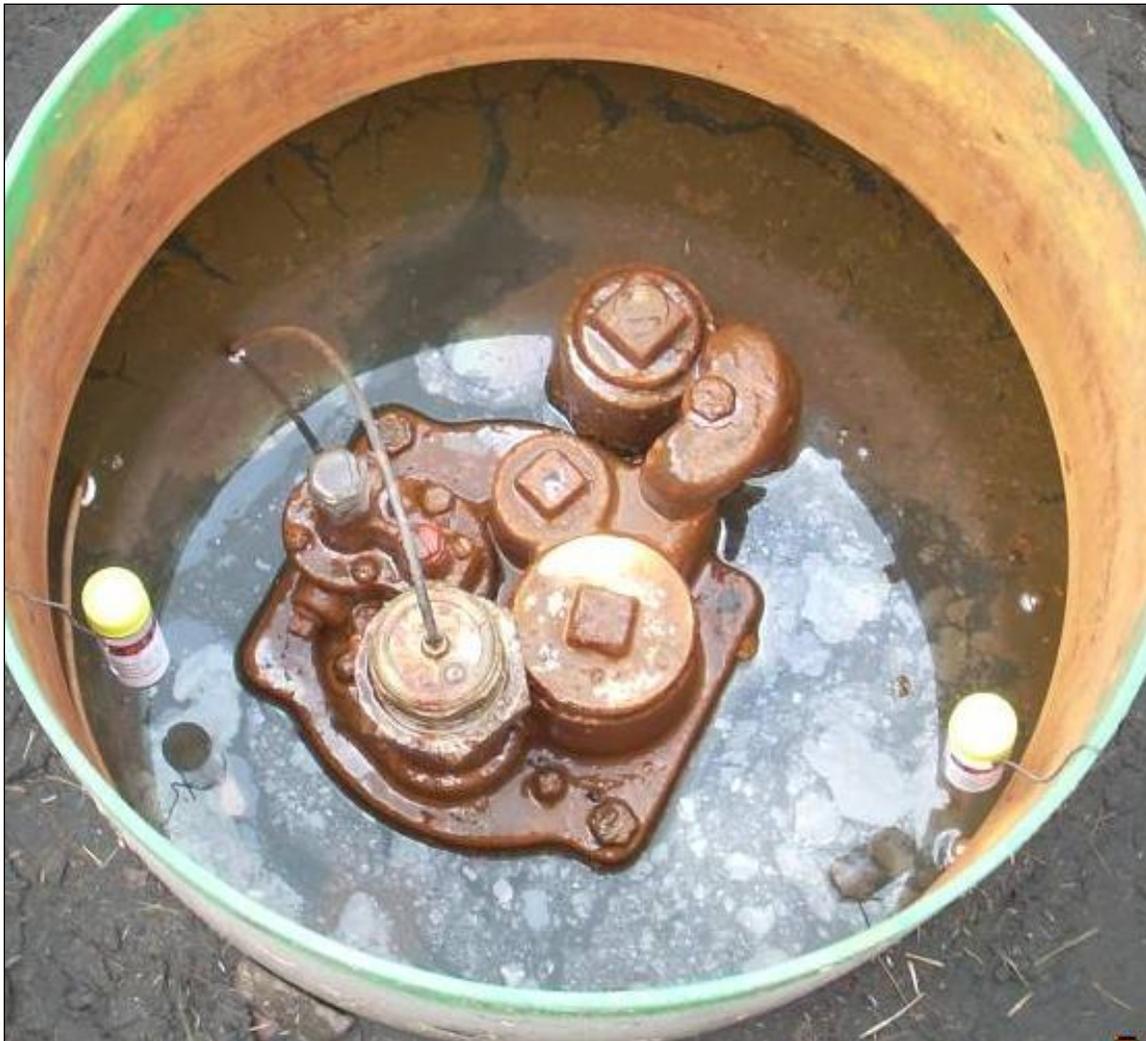
Sump 11

The stp sump has metal flex piping with isolation coating (roskote) and solid anode installed to protect piping from corrosion. The stp pump piping is 5 plus years old.

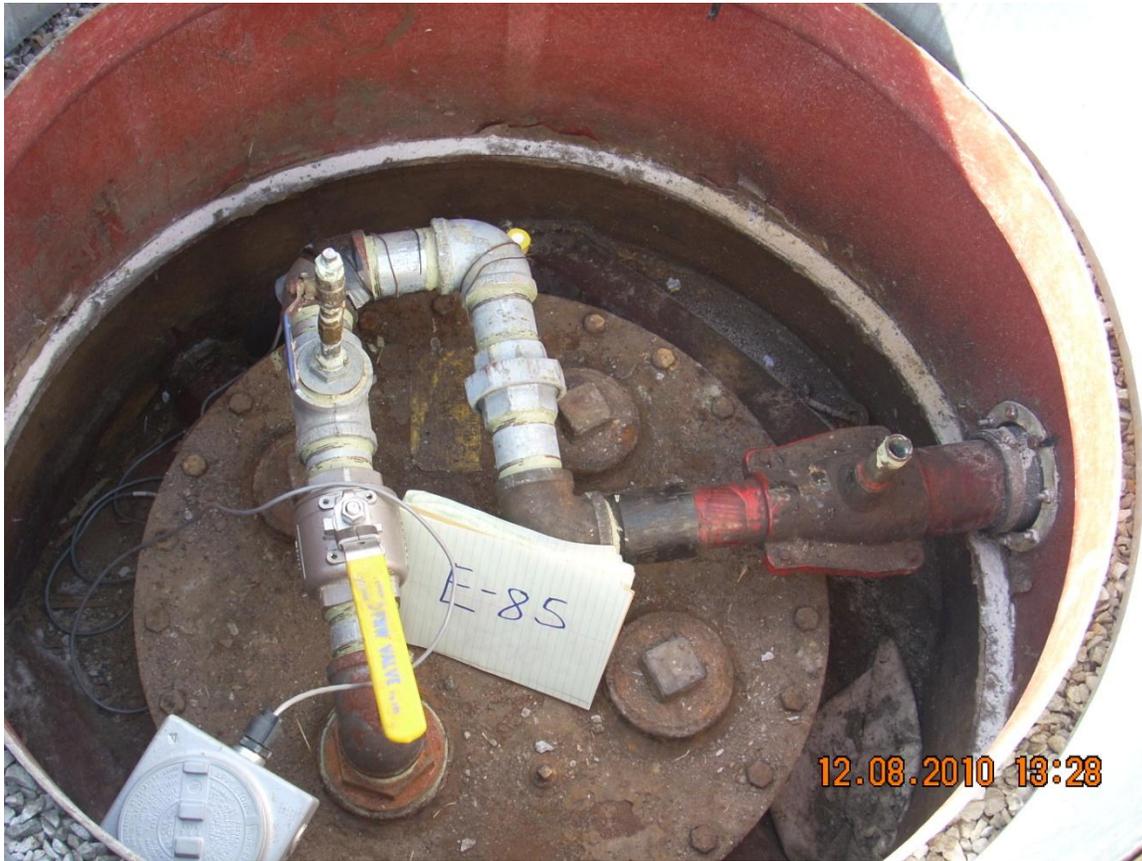
Sump 15

Note from state regulator that collected the samples. The last round of samplers contained surprising results, the results show high ethanol vapors. This is surprising to me since the sump is a suction sump, and not seeing major corrosion. The site is a state facility recently converted to e-85. There might have been an ethanol odor when I gathered samplers in December (I will go back by the business with our explosively meter).

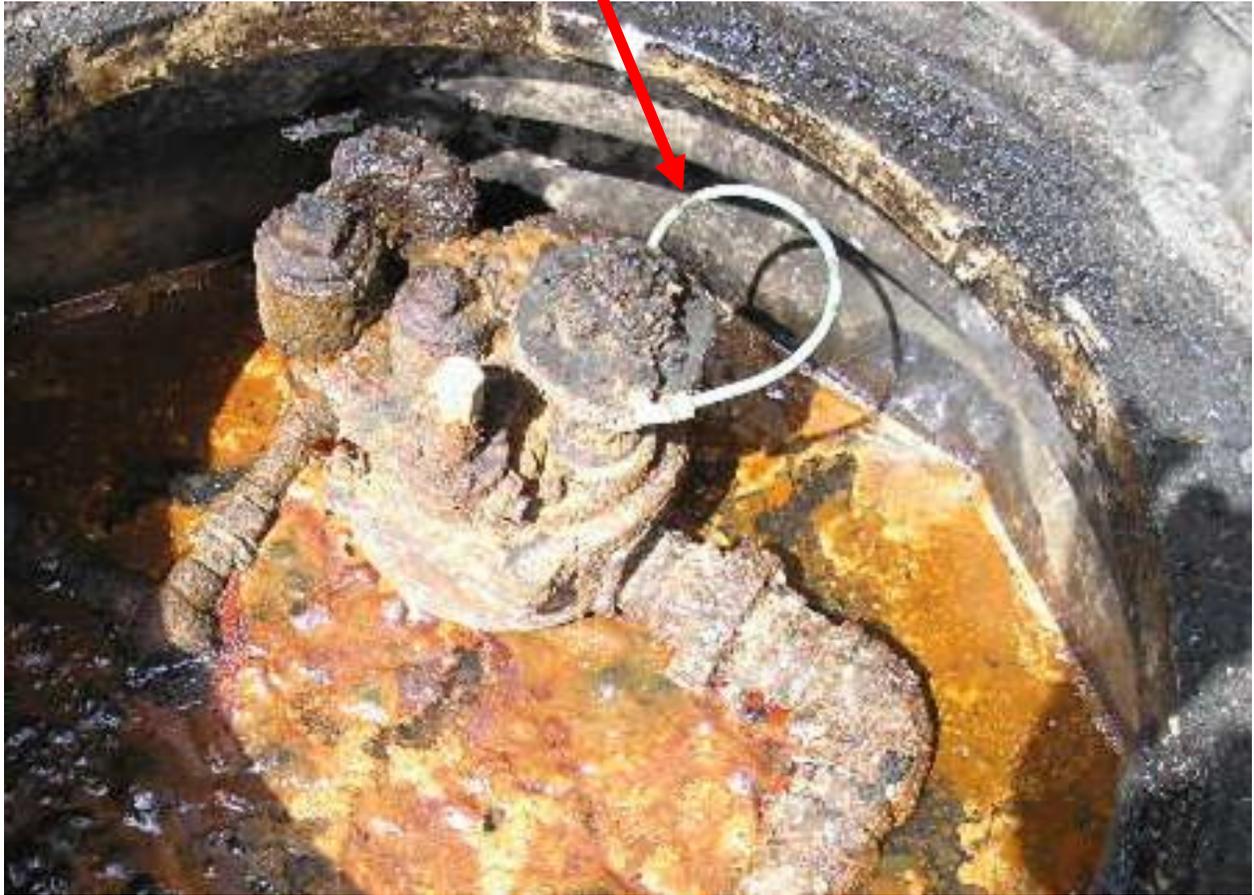
Sump 41

Note gap where corrosion has flaked off.

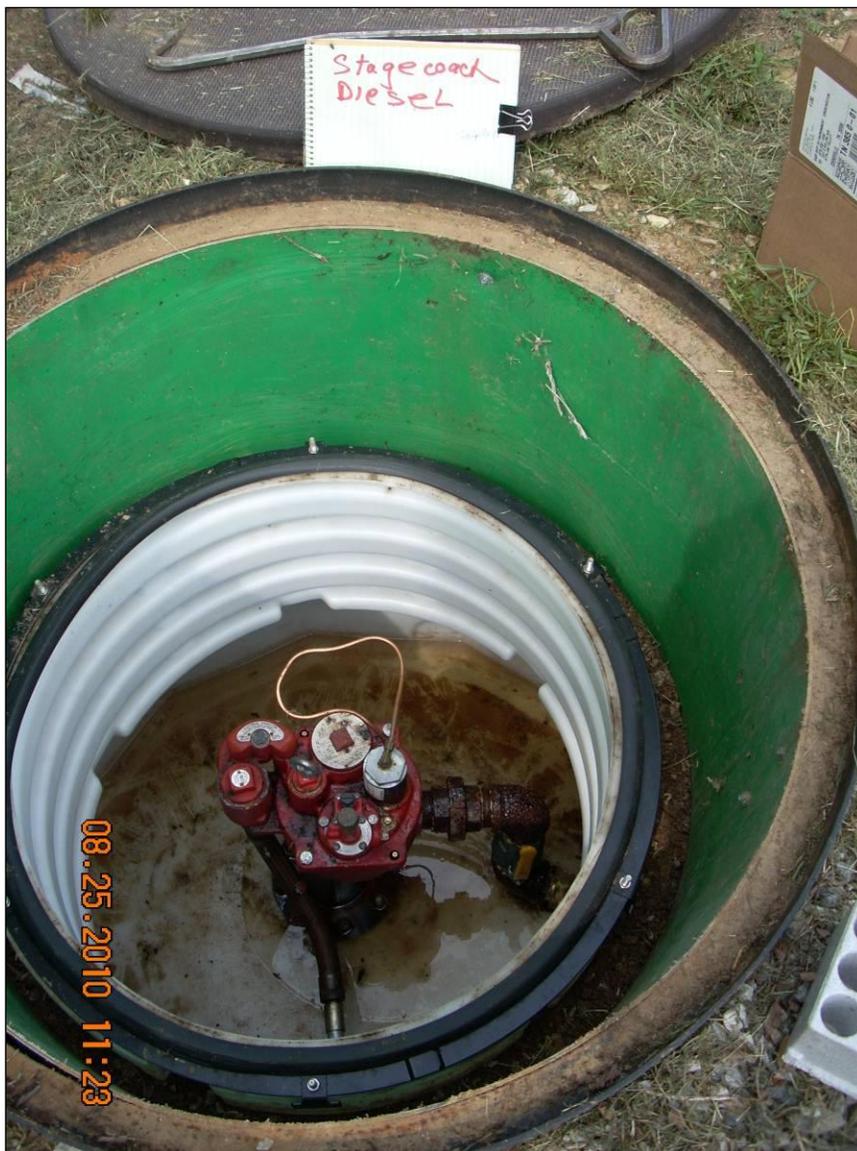
Sump 6

Not scored because no vapor samples were taken.

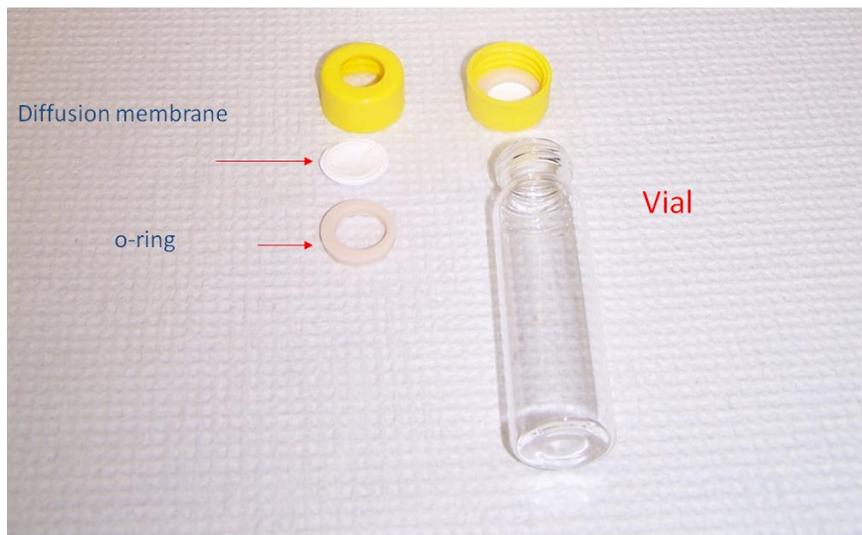
Figure 1. The components of the passive diffusion samplers.

The samplers were designed to provide an integrated determination of the average concentrations of ethanol and acetic acid in air in the sump when the sumps were sealed up and the concentrations in air were in their ordinary condition. The construction of the samplers is depicted in Figure 1. They were constructed using ordinary 40 mL volatile organic analysis (VOA) vials. The vials contained 1% trisodium phosphate dodecahydrate (TSP) as a preservative to prevent biodegradation of the ethanol or acetate in the sampler. The TSP maintained a pH of 10.5, which will prevent the growth of bacteria that degrade ethanol or acetate. The vials were filled with distilled water containing TSP in the laboratory. They were shipped to the field sites with a Teflon-faced silicone rubber septum. This is the septum that is used in VOA samples to contain organic compounds in water samples. At the field site, the sampling technician replaced the conventional screw cap containing a Teflon-faced silicone rubber septum with a screw cap containing a diffusion membrane. The membrane was composed of Supor (polyethersulfone). It contained perforations with a maximum diameter of 0.2 μm . The samplers were left in place for approximately one month. When they were recovered, the diffusion membrane was replaced with a screw cap containing a Teflon-faced silicone rubber septum, and the samples were shipped back to the R.S. Kerr Center in Ada, OK for analysis.

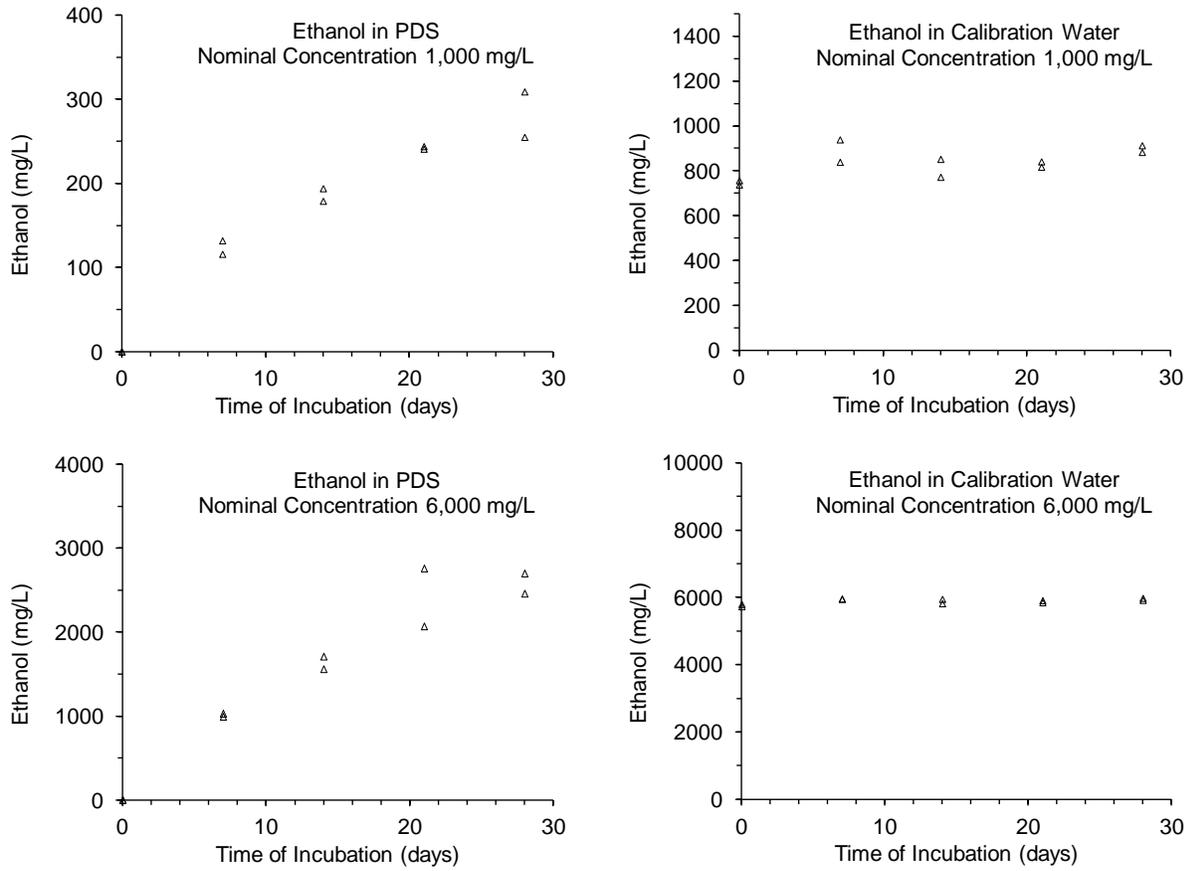
Figure 2. Concentrations of ethanol in the calibration water and in the passive diffusion samplers.

Figure 2 presents the measured concentrations of ethanol in the calibration water at each sampling period. Figure 3 presents the measured concentrations of acetate in the calibration water at each sampling period. The quality of the data was controlled in part by continuing calibration checks. Data were reported for ethanol if the continuing calibration check standards were within $\pm 20\%$ of the nominal value. Data were reported for acetate if the continuing calibration check standards were within $\pm 15\%$ of the nominal value. There was no evidence of loss or degradation of ethanol or acetate in the calibration waters. The agreement between duplicate diffusion samplers in each sampling period was acceptable considering the allowed variability in the individual analyses.

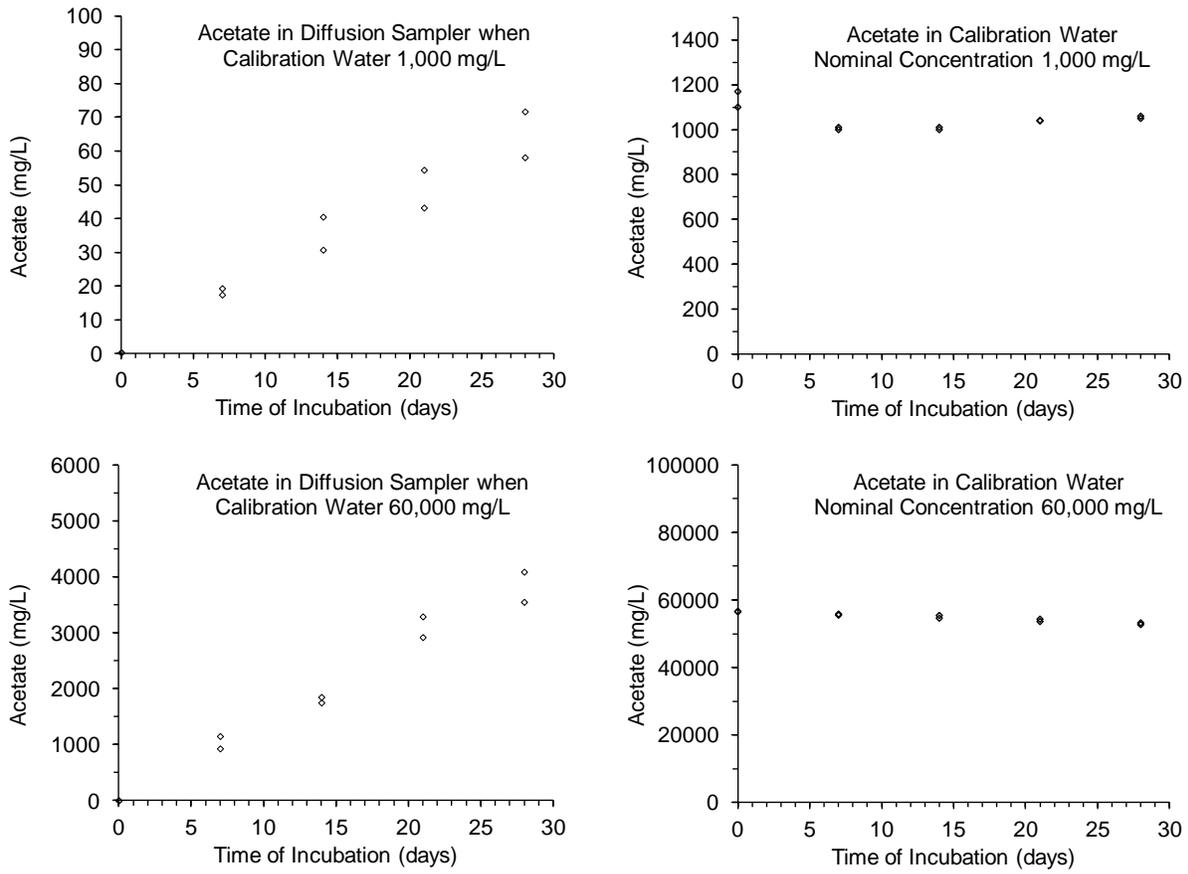
Figure 3. Concentrations of acetate in the calibration water and in the passive diffusion samplers.

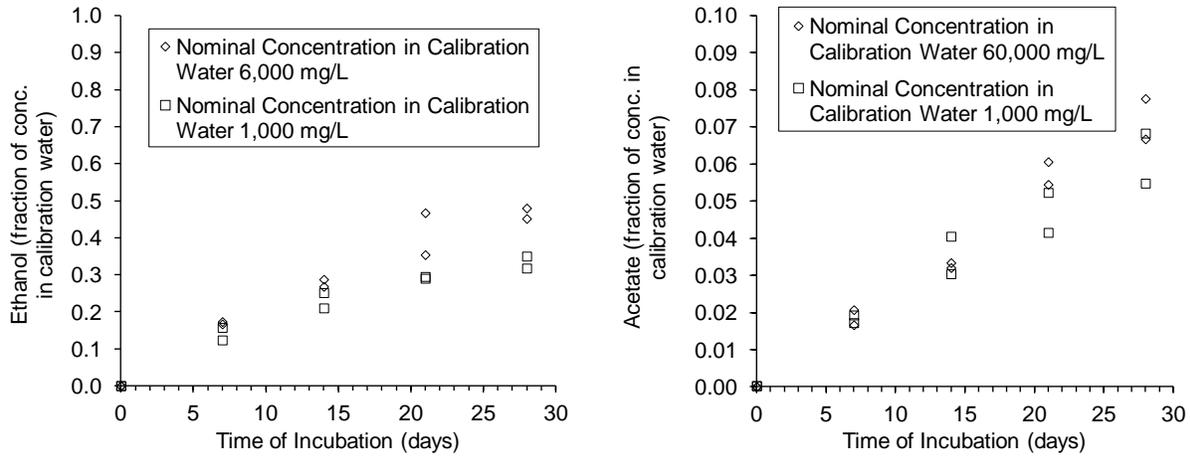
Figure 4. The fraction of the concentration of ethanol or acetate in the calibration water that was accumulated in the passive diffusion sampler over 28 days of incubation.

Figure 4 presents the accumulated concentration of ethanol or acetate in the passive diffusion samplers as a fraction of the measured concentration in the calibration water. There was a sixty fold difference in the concentrations of acetic acid in treatments 1 and 2. Over this range, the fractional recovery of acetate was in general agreement. There was a six fold difference in the concentrations of ethanol in treatments 3 and 4. After 28 days of incubation, the average recovery in treatment 4 was 28% less than the average recovery in treatment 3. The difference is statistically significant with a probability of error of 2.5%; however the bias has no practical affect on the data evaluation. Table 1 of *Corrosion in a STP Sump: What Causes It and What Can You Do About It?* indicates that the geometric means of samples with corrosion vary from the means of samples without corrosion by a factor near 100 fold. A factor near 1.28 fold will have no important affect on the comparison in Table 1.

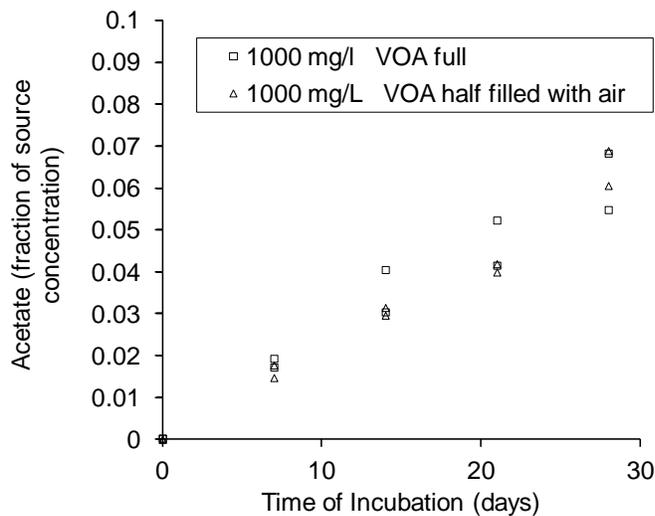
Figure 5. The fraction of the concentration of acetate in the calibration water that was accumulated in the passive diffusion sampler over 28 days of incubation if the passive diffusion sampler was half filled with air.

Some of the passive diffusion samplers were returned to the laboratory with a significant air headspace. Presumably, water evaporated from the samplers during incubation in the sump. The water loss was never more than 50% of the total volume of the sampler. To determine if water loss affected the performance of the sampler, the calibration was repeated for acetate at 1000 mg/L in the source water using passive diffusion samplers that were half filled with water and samplers that were entirely filled with water. Results are presented in Figure 5. There was no difference in the performance of samplers filled with water and samplers half filled with water. The loss of water had no detectable effect on the accumulation of acetate in the samplers.

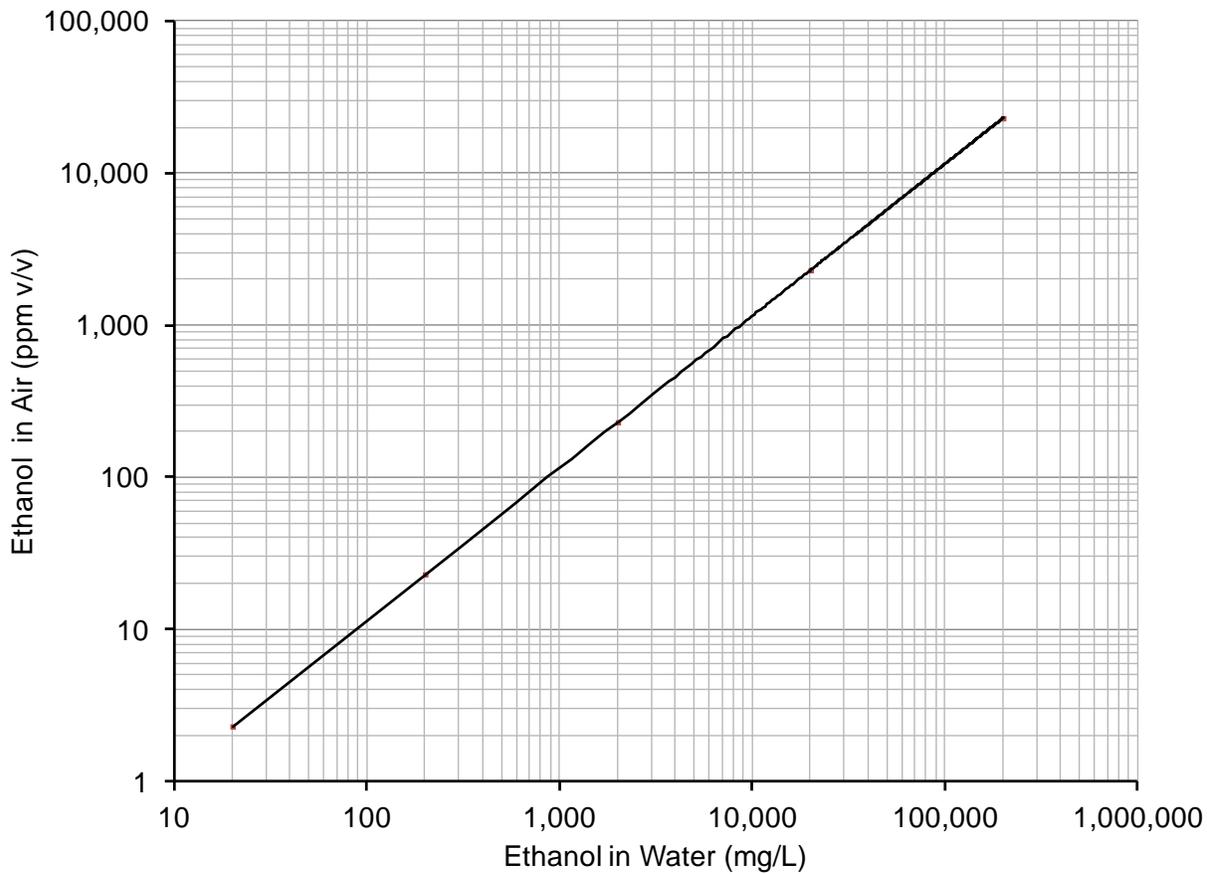
Figure 6. Concentrations of ethanol in air in equilibrium with concentrations in water.

The biodegradation of ethanol to acetic acid and the chemical reaction between acetic acid and metallic copper occur in an aqueous environment. For this reason, the concentrations in air are expressed as an equivalent concentration in water, based on the equilibrium distribution of ethanol or acetic acid between air and water. The concentration in air in more conventional units can be recovered using Figure 6 and Figure 7. Figure 6 compares the concentrations of ethanol that would be expected in air based on equilibrium with concentrations in water assuming a Henry's Law constant for ethanol and water of 190 moles per liter in water per atmosphere. Figure 7 compares the concentrations of acetic acid that would be expected in air based on equilibrium with concentrations in water assuming a Henry's Law constant for acetic acid and water of 5500 moles per liter in water per atmosphere.

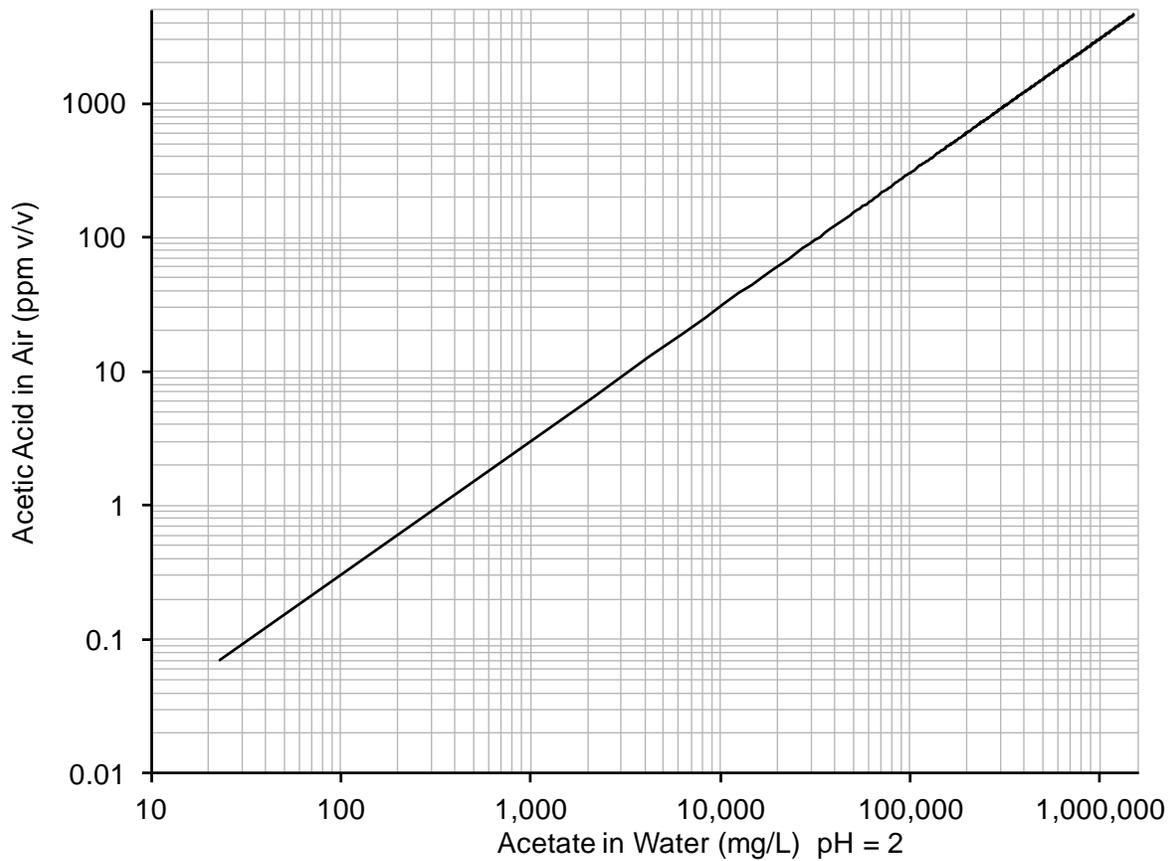
Figure 7. Concentrations of acetic acid in air in equilibrium with concentrations of acetate in water.

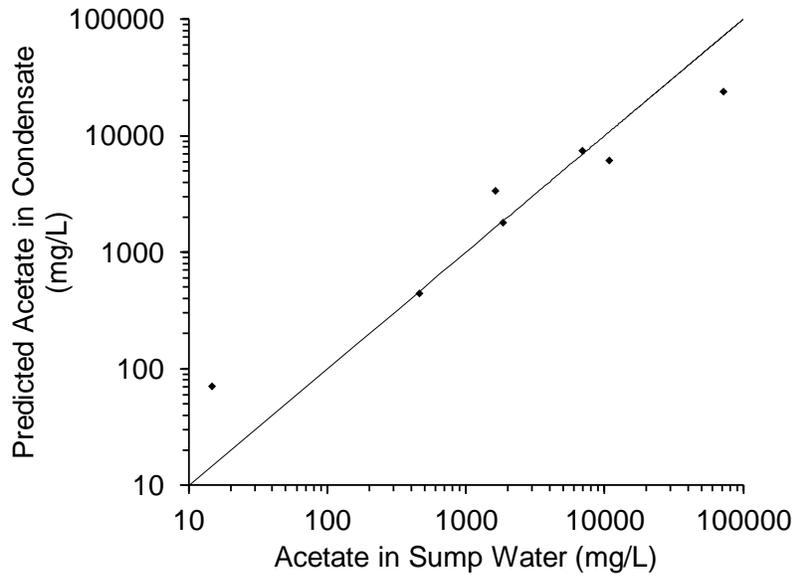
Figure 8. Comparison of measured concentrations of acetic acid in sump water to predicted concentrations in condensate water based on the measured concentrations in the vapor sampler.

The results for acetate are presented in Figure 8. At concentrations below 10 mg/L there was more scatter and these data are not shown. Most of the corrosion occurred in sumps with more than 10 mg/l of ethanol or acetate (Figure in 3 of *Corrosion in a STP Sump 1: What Causes It and What Can Be Done About It?*). In Figure 8 the correspondence between the concentrations of acetate measured in water and concentrations predicted from the vapors samplers was good.

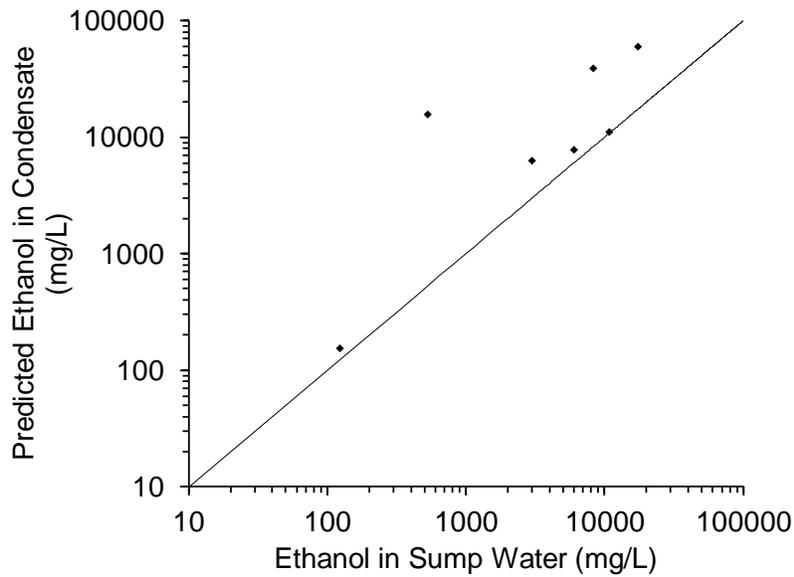
Figure 9. Comparison of measured concentrations of ethanol in sump water to predicted concentrations in condensate water based on the measured concentrations in the vapor sampler.

The results for ethanol are presented in Figure 9. As was the case for acetic acid, at concentrations below 10 mg/L there was more scatter and these data are not shown. The association between the concentrations of ethanol measured in water and predicted from the vapors samplers was not as good as was the case for acetic acid. There tended to be more ethanol in the water in the sampler. This may reflect degradation of ethanol to acetate in the sump water. The water in the sampler was preserved with trisodium phosphate and the ethanol did not degrade in the samplers. In any case the association was close enough to indicate that the passive samplers could make a useful prediction of the concentration of ethanol in condensation water in the sumps. The concentration in the sump was within an order of magnitude of the predicted concentration in the condensation water.
